**SSC-331**

## DESIGN GUIDE FOR SHIP STRUCTURAL DETAILS

# SHIP STRUCTURE COMMITTEE 1990

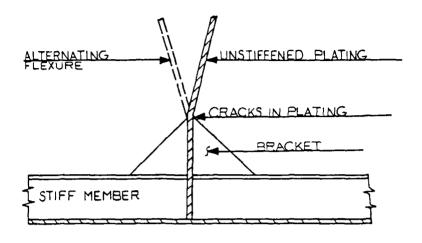
FIGURE 2-1

FLEXURE OF UNSTIFFENED PLATING ABOUT BRACKET

TOE LEADING TO CRACKS (REF.49)

Ref. 49 includes many sketches of failures in ship structural details. The bulk of failure examples were taken from a booklet by "Lloyd's Register of Shipping" (Figs. 2-1, 2-2, 2-3 and 2-1) and a paper by Mr. A. Haaland on ship structural design (Figs. 2-5 and 2-6). Figs. 2-1 and 2-2 illustrate a typical problem when installing brackets on stiffeners in way of a watertight or oiltight bulkhead. The bulkhead plating is relatively flexible and tends to bend over the hard spot caused by the relatively stiff bracket. The high stresses produced in the bulkhead frequently lead to cracks in the bulkhead. Fig. 2-3 illustrates similar problem areas and improved details which should reduce the potential for failures. Sound structural design considerations such as continuity and proper reinforcement can solve most of the problems shown in Fig. 2-3. Similar suggested improvements to typical ship structural details are presented in Refs. 30, 53, 58, 62, and 68. Fig. 2-4 shows that serious fractures can occur from very simple details if special care is not taken in design and construction. In this case, the girder web butt weld probably failed first due to the difficulty in providing good endings to the weld at "X". In general, scallops should be kept to a minimum.

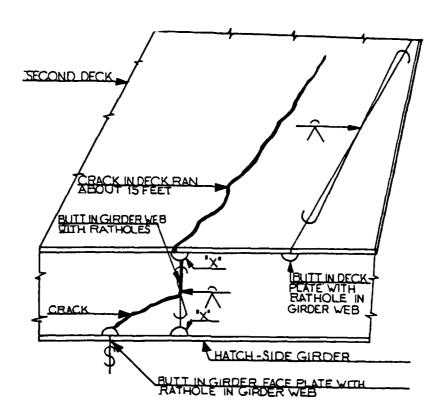
FIGURE 2-4

FRACTURE OF HATCH SIDE GIRDER AND DECK PLATE AT "POOR RATHOLE" CUTOUT (REF. 49)

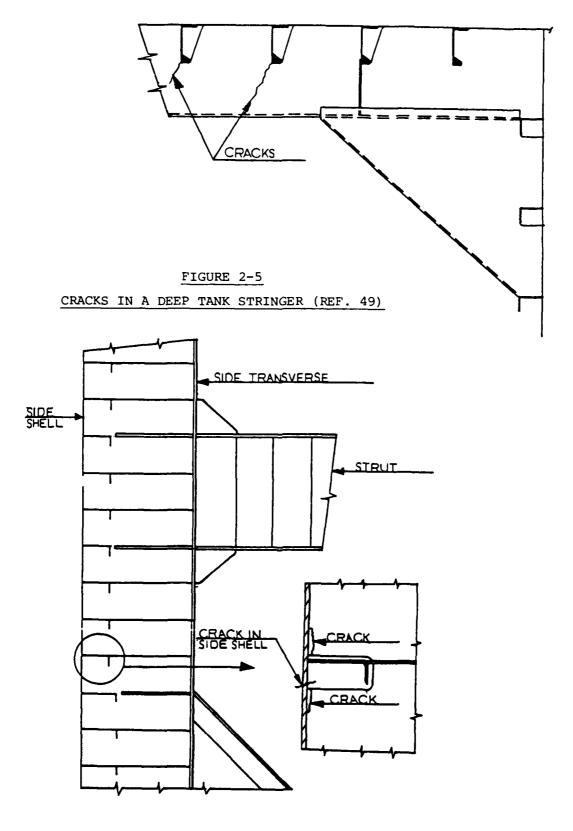
FIGURE 2-6

CRACKS OCCURRING IN LARGE TANKERS AT THE
JUNCTION OF SIDE LONGITUDINALS AND WEB FRAMES (REF. 49)

Fig. 2-6, ". . . shows cracks occurring at the junction between side shell longitudinals and transverse web frames because the cross-sectional area of the connection is too small, thus causing high shear stresses at the support. Normally cracks occur in the fillet weld, and when the connection has first been broken secondary cracks will appear in the shell at the edge of the scallop in the vertical web for the longitudinal and at the weld connection between the web and the shell.

"This problem may be eliminated by increasing the cross-sectional area of the connection with brackets, collar plates or lapped stiffeners." (Ref. 49)

As drawn in Fig. 2-6, there is no direct connection of the longitudinal to the web frame. Consequently, the end reaction of the longitudinal must first be transferred to the flat bar stiffener and then into the web frame. This connection between the longitudinal and the flat bar stiffener has been a source of cracks in heavily loaded members even when a direct web to longitudinal stiffener connection is provided as described in the next paragraph.

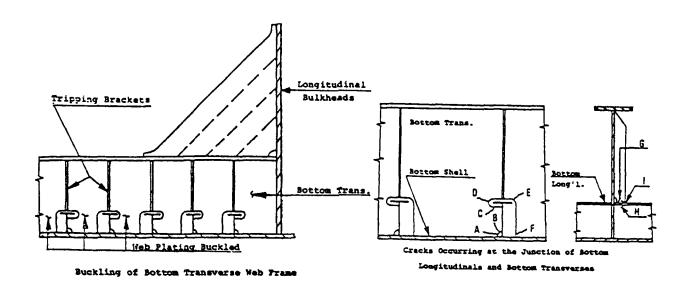
FIGURE 2-7
FAILURES IN CONNECTION DETAILS (REF. 49)

Fig. 2-7 illustrates both cracking and buckling failures in way of structural intersections. As stated in Ref. 49: "Investigation reveals that approximately 75% of the total number of fractures found around slots are of Type G, H and I [cracks in or in way of the flat bar attached to the longitudinal flange]. Since most [of] the webs having D, E, and F type fracture [cracks in the girder web plate] also have G, H and I type fracture, it is considered that the fractures around slots may have begun at the lower end of the web stiffener as type G, H and I and then developed to type D, E and F type fractures. Type A, B and C [additional cracks in the girder web plate] occur rarely and may be a result of vibration of the transverse webs." Fig. 2-8 shows the configuration of a typical side shell longitudinal connection to a web frame and the sequence of crack initiation most commonly observed. Figs. 2-7 and 2-8 appear to be in general agreement on the sequence of crack initiation. "Although these details were used successfully for many years with smaller vessels, the increased draft, web frame spacing, and size of the larger tankers were probably not fully considered in designing the details." (Ref. 60)

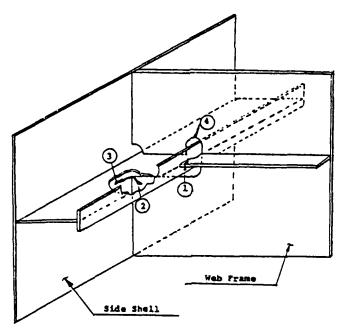
FIGURE 2-8

- Initiation of Crack in Flat Bar Stiffener
- 2 Crack at Free Edge of Cut-out
- 3 Crack in Side Shell Plating
- 4 Crack at Radius of Cut-out

SEQUENCE OF CRACK INITIATION (REF. 60)

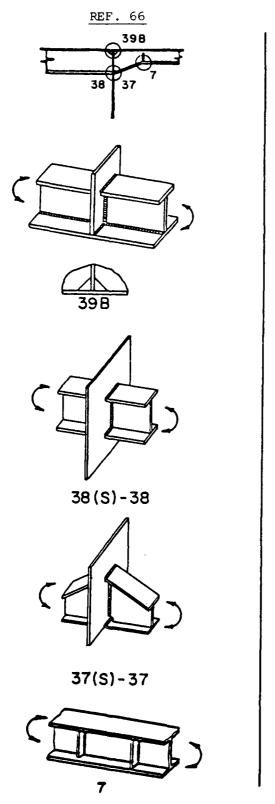
## FIGURE 2-11

## LOCAL FATIGUE DETAILS FOR SHIP STRUCTURAL DETAIL 1-A-1

Suggestions for modeling typical ship structural details using a series of simpler local fatique details are given in Appendix A of Ref. 66. As an example, the left-hand side of Fig. 2-10 shows the local fatigue details recommended for analyzing ship structural detail 1-B-4 (this designation refers to family number 1, family group B, and detail number 4 as described in Section 3 and shown in Fig. 3-1). It is suggested that several additional local fatigue details be included as shown on the right-hand side of Fig. 2-10. Local fatigue detail 39C is a square cornered, lapped connection which can have a quite high stress concentration factor and consequently a low fatigue life. Local fatigue detail 17(S)-17 is suggested because the entire load in the stiffener must be transmitted to the bracket plate. Local fatique detail 30A is probably the most significant potential failure mode. This represents bending of the relatively flexible bulkhead plating over the "hard spot" of the relatively stiff bracket which has been the cause of many cracks as shown in Figs. 2-1, 2-2, and 2-3. The basic loading may be due to either vibration or hydrostatic pressure on the bulkhead and the ship loading history (stress range versus cycles) is not well defined for either load. As Ref. 66 indicates, most of the available ship loading histories are for longitudinal hull girder bending stresses. Very little information on ship loading history is available for secondary structures such as transverse bulkheads or web frames. Fig. 2-11 presents similar data for ship structural detail 1-A-1. Local fatigue detail 37A represents flexing of the bulkhead plate similar to (but less severe than) local fatigue detail 30A of Fig. 2-10. Local fatigue detail 7-A shows a flange knuckle with tangency chocks, flange butt weld, and fillet welds to the flange all of which contribute to the fatigue problem. Local fatigue details 39C, 37A, and 7A are new configurations which are not currently covered by Ref. 66. However, neither of these details (1-B-4 or 1-A-1) is recommended for normal ship use (see further discussion in Section 3).

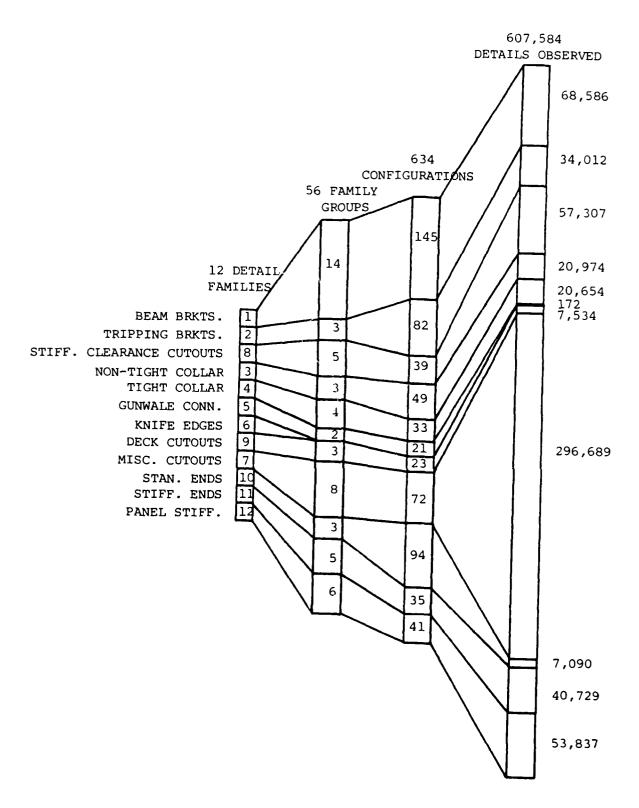
FIGURE 2-12

SUMMARY OF STRUCTURAL DETAILS SURVEYS

Fig. 2-12 summarizes the resulting data: 607,584 details were observed in 634 different configurations which were assigned to 56 family groups and 12 families. Fig. 2-13 gives a description of the primary function of each family along with a sketch of a typical configuration. Note that the family numbers are not in order. Family No. 8 (Stiffener Clearance Cutouts) is inserted before Family Nos. 3 and 4 (Non-tight and Tight Collars) because these details are so closely related. Also, Family No. 9 (Structural Deck Cuts) is inserted before Family No. 7 (Miscellaneous Cutouts) because the former is more important and should be discussed first. This order is maintained throughout the present report. Because of survey limitations, no Knife Edge Crossings (Family No. 6) were observed.

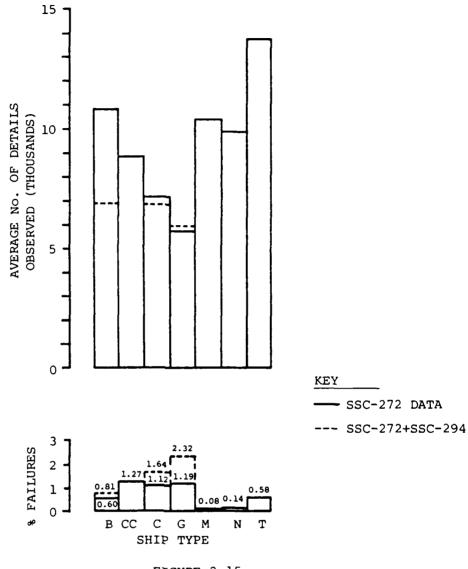
FIGURE 2-15

DATA SYNTHESIS BY SHIP TYPE

Fig. 2-15 shows the average number of details observed and failure rate versus ship type. The most interesting result is that miscellaneous and naval ships had very small failure rates of 0.08 and 0.14 percent, respectively. Since only two miscellaneous ships were observed versus nine naval ships, the results from the latter type should be given a much higher confidence level. Since naval ships had almost an order of magnitude smaller failure rate than the average ship, the differences in naval and commercial ship details are discussed in Chapter 3 and Appendix C of this report. Ref. 72 gives the exact geometry of many naval ship details.

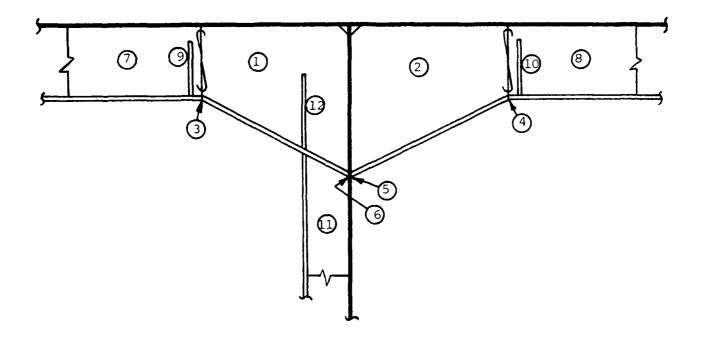
TABLE 4-1

SAMPLE CALCULATION: BUILT-UP BEAM BRACKET IN WAY OF BULKHEAD STIFFENER

Calculations for 8"x61/2"x24#I-T stiffeners for detail 1-A-3:

TABLE &	
MEMBERS	DESCRIPTION	ITEM NO.	MANHOURS
① & ②	0.25" Brackets(includes welds on all sides)	B-3-1	2x1.41 =2.82
3 & <b>4</b>	6.5"x0.4375" Flat Bar Ends (with butt welds)		2x1.16* =2.32
S & 6	6.5"x0.4375" Flat Bar Ends (full penetration tee welds)	B-16-7	2x1.16**=2.32
7 8 9 6 10	Tee Stiffener Ends (no welds)		2x0.11 = 0.22
<b>@ 3</b> @	2.75" x7" x 0.25" Chocks	B-5-1	$4x0.26^* = 1.04$
$\odot$	Bhd. Stiffener End (with		
•	fillet welds)	B-18-7	0.76
<b>1</b>	3" x 10" x 0.4375" chocks	B-5-1	$2x0.51^* = 1.02$

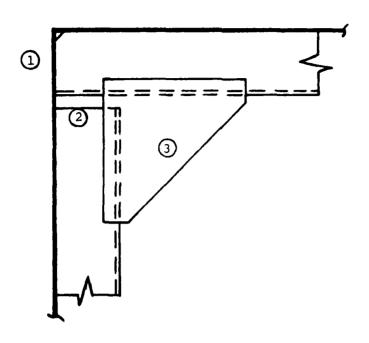
TABLE 4-3

SAMPLE CALCULATION: PLATE CORNER BRACKET

Calculations for 8"x4"x1/2"L for detail 1-C-3:

MEMBERS	DESCRIPTION	TABLE & ITEM NO.	MANHOURS
1	Cut & weld stiffener web & flange at end	B-17-5	0.72
2	Square cut stiffener end (no weld)	B-17-1	0.11
3	18" x 18" x 0.5" bracket	B-1-1	1.66
Total Fab	orication Time		2.49 mhrs.

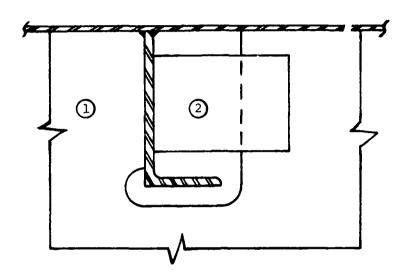
TABLE 4-4

SAMPLE CALCULATION: NON-TIGHT COLLAR

Calculations for 8"x4"x1/2"L for detail 3-A-4:

TABLE &	
MEMBERS	DESCRIPTION	ITEM NO.	MANHOURS
1	Cut & weld web plate	B-6-6	0.33
2	7" x 5" x 0.5" lapped collar	B-7-1	0.76
Total Fab	orication Time	······································	1.09 mhrs.

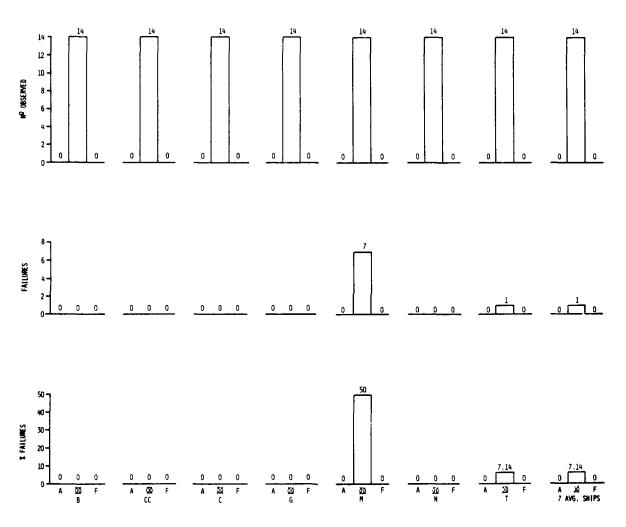
FIGURE A-6

GUNNALE CONNECTION DETAILS-FAMILY NO S
(NORMALIZED DATA FOR SEVEN SHIPS OF EACH TYPE)

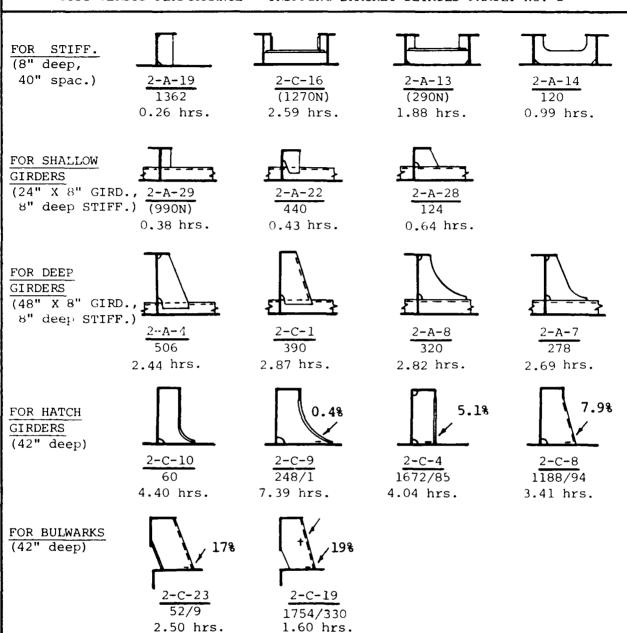
#### FIGURE C-5

## COST VERSUS PERFORMANCE - TRIPPING BRACKET DETAILS-FAMILY NO. 2

The four stiffener tripping brackets shown in Fig. C-5 represent different design conditions so a cost/performance trade-off between them is not appropriate. The least expensive detail (2-A-19) is only suitable for relatively light stiffening on thick plating unless the chock is "backed-up" by structure on the opposite side of the plating. The next detail in order of fabrication cost is 2-A-14. This detail ties two stiffeners together which considerably increases the lateral support provided. The detail shown is one piece but it can easily be built-up from flat bars. If the plating is subject to a lateral load, this bracket detail must be designed to carry a portion of the load to the stiffeners. As the stiffener sizes increase and/or the lateral load on the plating increases, additional stiffness and strength, respectively, are required for the portion of the detail between the stiffeners and detail 2-A-13 results. When the depth of the stiffeners increases and the length of the flat bars becomes over six inches, tee shapes are specified for the vertical members as in detail 2-C-16 to provide sufficient lateral stiffness.

The lower end of the flanges of the first two brackets shown in Fig. C-5 are sniped while the hours for the last two brackets are with the flanges welded to the deck. Most of the failures observed in the latter two brackets occurred where the flanges had been sniped where they meet the deck. Detail 2-C-8 is the least expensive and generally provides adequate service when the flange is welded to the deck and the detail is adequately "backed-up" by structure below the deck. Detail 2-C-4 requires more time because of the welding associated with its centered face plate. The primary reason for the difference in cost for the first two brackets is the larger size of bracket detail 2-C-9.

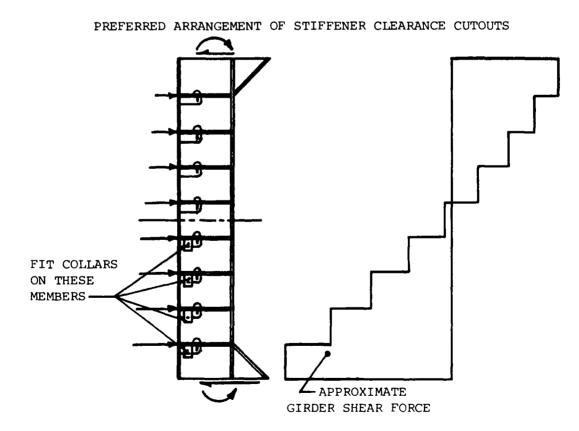
FIGURE C-8

STIFFENER CLEARANCE CUTOUTS IN A VERTICAL GIRDER

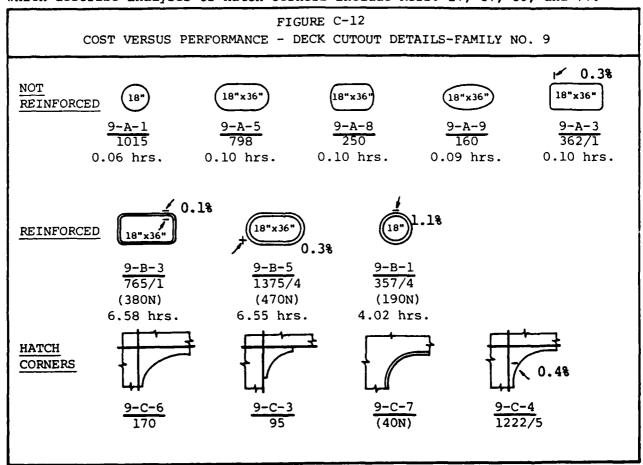
Note: Hours shown are for 3/4" plate and automatic burning equipment.

The expense of fitting reinforcement for openings in structural decks is well illustrated by Fig. C-12. With modern burning equipment, holes can be cut for a negligible cost compared to the expense of fitting and welding reinforcement. Construction costs can be minimized if necessary openings can be located in low stress areas and left unreinforced. An attractive alternative might be to group openings in a thicker plate inserted in the deck utilizing existing butts and seams. The cost of cutting the thicker plate would be negligible compared to the cost of fitting reinforcement.

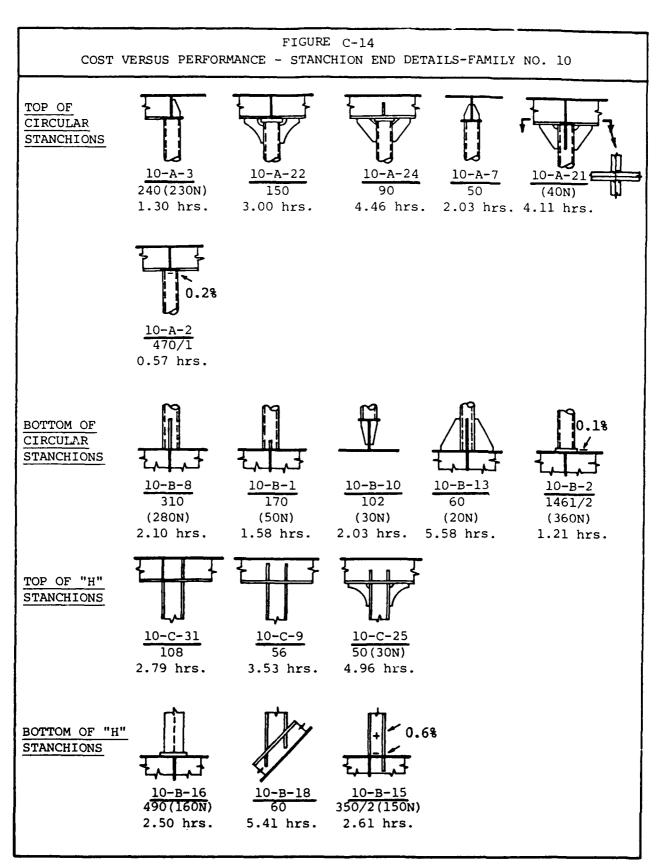
Note: Hours shown are for 8" dia. x1" thick pipe or 8"x8"x48# WF.

The details shown in Fig. C-14 show a direct relationship between the number of added pieces and the fabrication cost. The numbers observed followed the opposite trend so this is one group where the least expensive detail was also the most often observed.

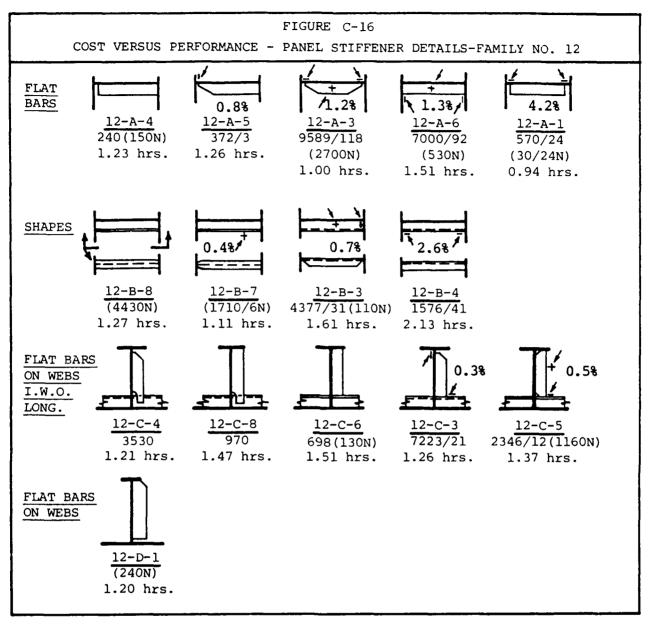
Note: Hours shown are for  $6"x\frac{1}{2}"$  F.B.,  $6"x4"x3/8" \perp$ , or 6"x4"x16# I- $\perp$ , all 36" long.

Shapes performed better than flat bars as panel stiffeners and tees performed better than angles. Angles are slightly more expensive than tees for the sizes and arrangements shown in Fig. C-16 because the angle has a thicker web and consequently requires heavier welds than the tee.
